**SUBJECT: START 3, EPA Region 8, Contract No. EP-W-05-050, TDD No. 1008-13
Trip Report-Revision 1-for August 2011 Sampling and Field Activities,
Upper Animas Mining District, Silverton, San Juan County, Colorado**

TRIP REPORT
Upper Animas Mining District
Silverton, San Juan County, Colorado

**Photo Log
Cement Creek
San Juan County, Colorado
August 2011**

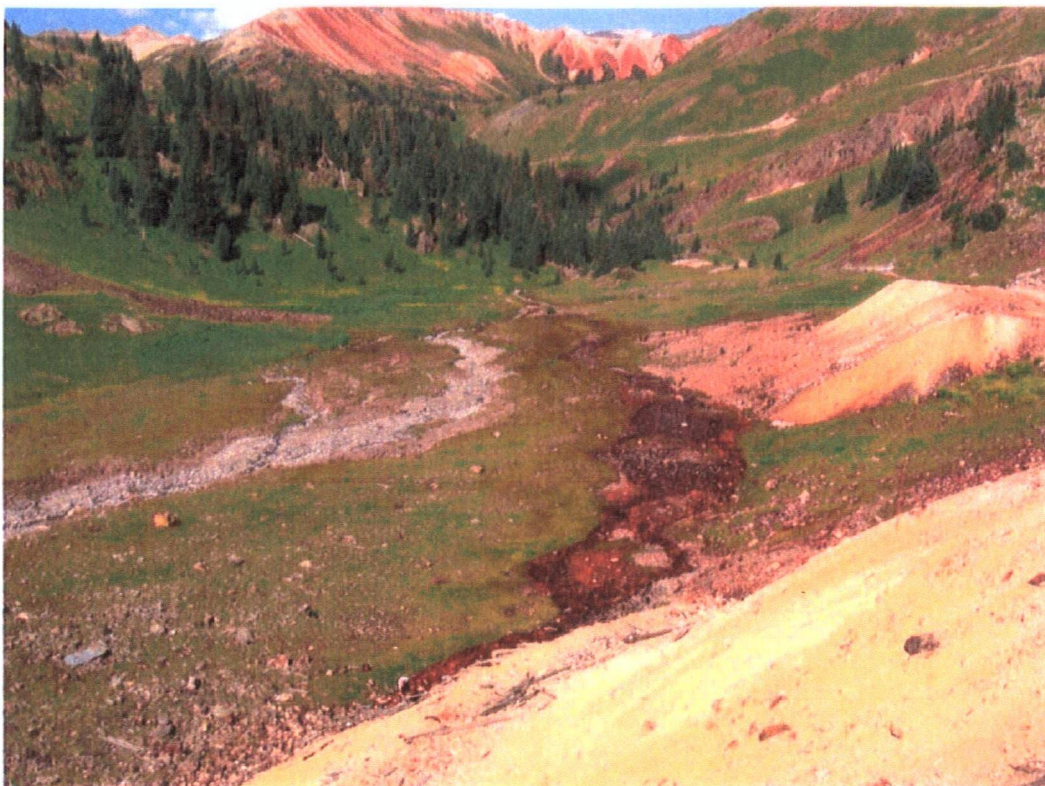
PHOTO 1

View to the west of surface water flowing from the toe of the Grand Mogul Mine waste rock dumps toward Cement Creek. Note iron staining of flow path.

- **Grand Mogul Mine:** The overland flow pathway for the Grand Mogul Mine begins at the western toe of the main mine waste pile and continues westward for approximately 300 feet until it enters Cement Creek (Appendix A, Photos 1 & 2). The actual point of exit from the ground is buried by the mine waste. The overland flow path as shown in Photo 1 is heavily stained with iron oxides (that begin to precipitate out of solution when the pH rises above 3.5) as compared to the stream course of Cement Creek on the left center of the photograph.

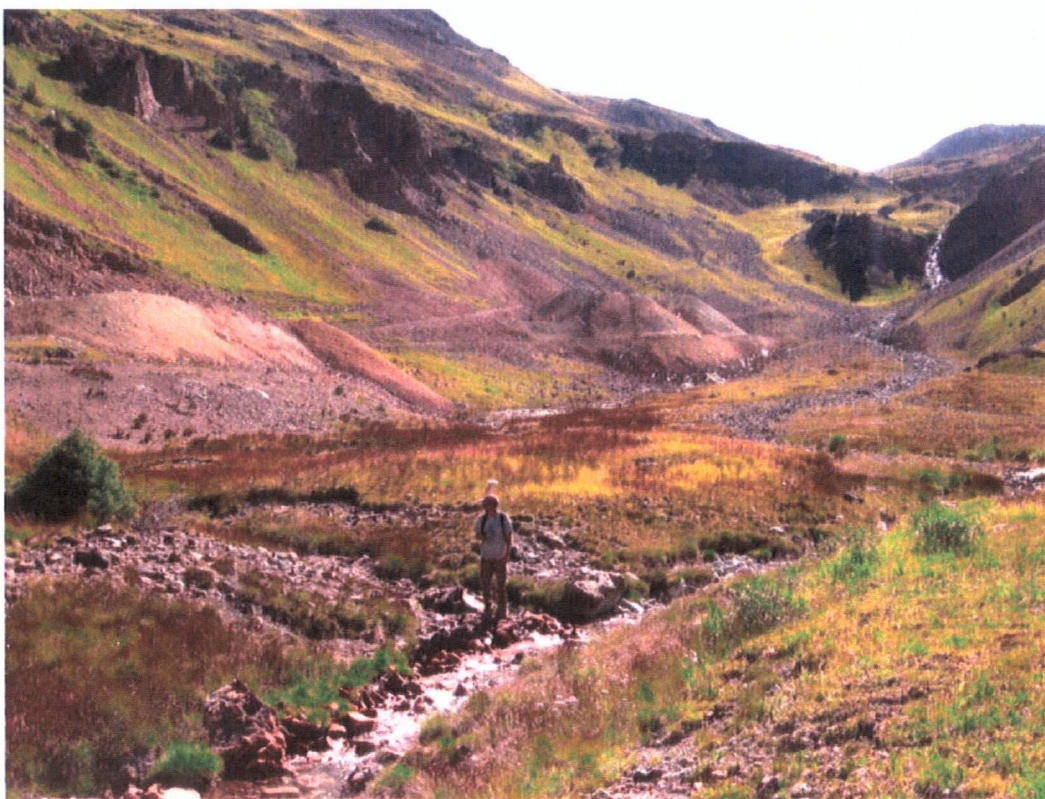
PHOTO 2

View to the east of the PPE from the Grand Mogul Mine into Cement Creek. Note iron staining of rocks in Cement Creek downstream of flow from Grand Mogul Mine. J. Miller of START at PPE collecting GPS location data.

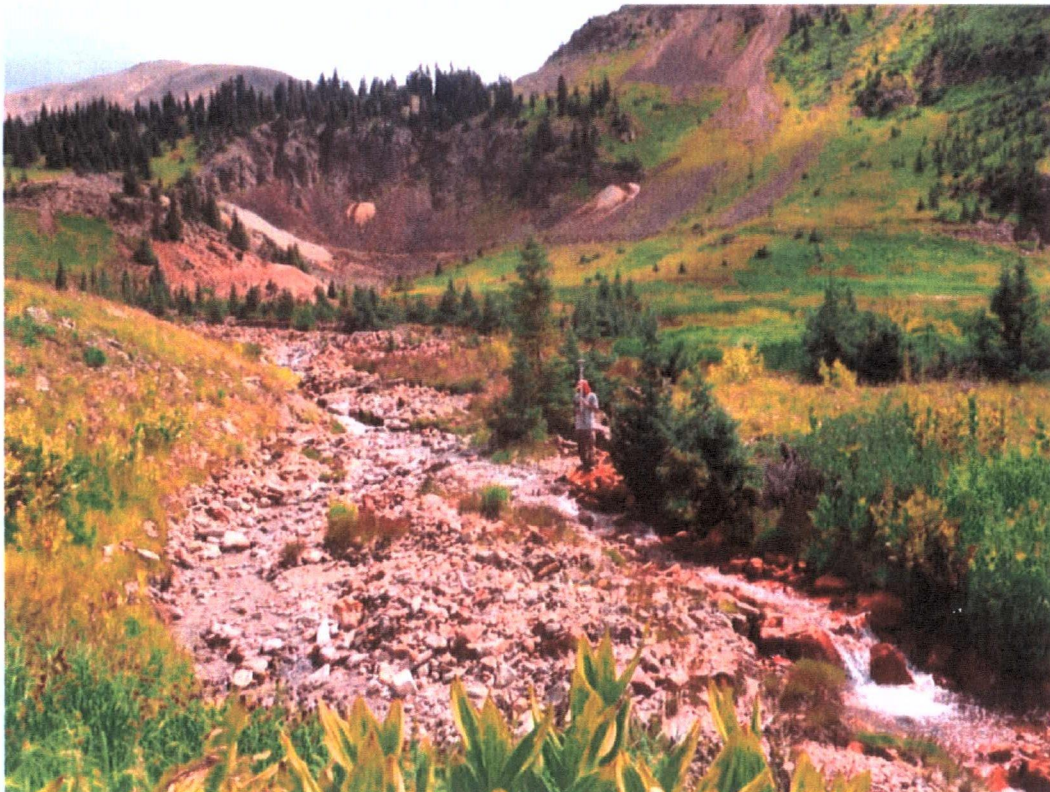
PHOTO 4

View to the east of the PPE of the discharge from the Mogul Mine into Cement Creek. The surface water pathway from the adit flows down to the road on the other side of the white patch of waste rock and through the wetlands. Note iron staining of Cement Creek on the inflow side of the creek from the PPE where J. Miller of START at PPE collecting GPS location data.

- **Mogul Mine:** The discharge from the Mogul exits through an adit on the northeast side of the mine waste pile and flows across the top of the mine waste pile in a tarp lined ditch to the access road. Once the adit discharge crosses the road, it flows over a mixture of mine waste and mine trash into a series of wetlands below the mine (Appendix A, Photo 3). The overland flow pathway from the Mogul Mine covers approximately 1,200 feet before the PPE into Cement Creek. It can be observed that iron oxides are precipitating on the side of Cement Creek where discharge water from the Mogul Mine is entering Cement Creek (Appendix A, Photo 4).

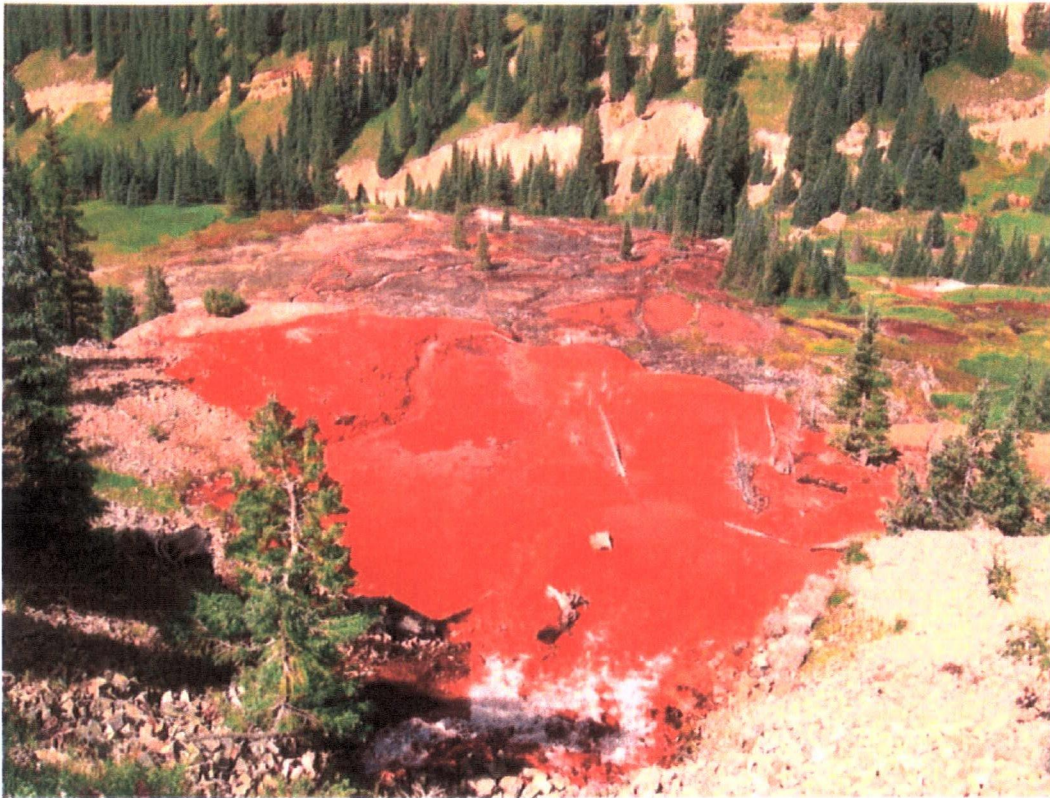
PHOTO 5

View to the west of the adit discharge from the Red and Bonita Mine. Note the strong color of iron oxide precipitation and the staining to Cement Creek along valley floor.

where it flows southward, then into a culvert directed westward under the road, and then directly westward across a barren iron oxide stained landscape to Cement Creek (Appendix A, Photo 5). The overland flow path after flowing under the road splits into two streams in the barren area before entering Cement Creek. The more upstream flow path was visually estimated to carry approximately 75 percent of the flow, and the smaller stream enters Cement Creek approximately 50 feet downstream of the larger stream. Photo 6 shows the upper dominant discharge point. Note the iron oxide staining in the Cement Creek streambed on the side of the PPE from the Red and Bonita Mine (Appendix A, Photo 6).

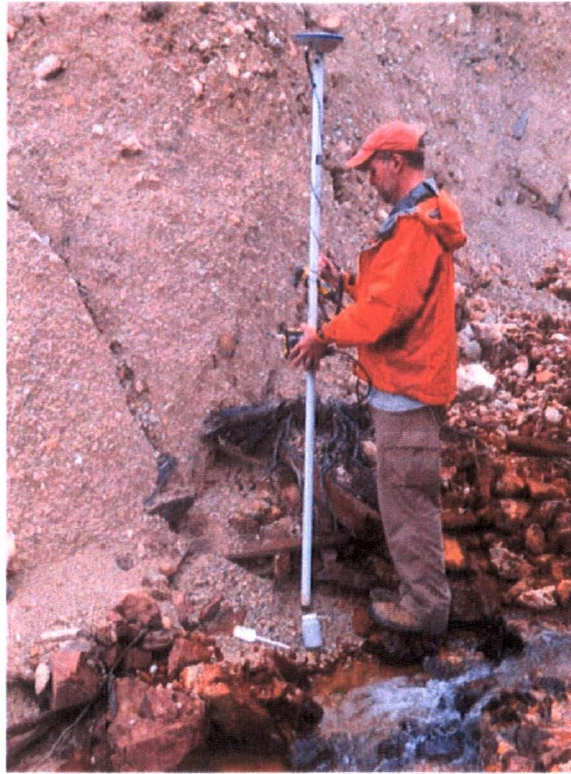
PHOTO 7

Gold King 7 Level Mine waste rock pile being eroded by the North Fork of Cement Creek. Note the erosion rills on the waste rock pile and undercutting by stream. J. Miller of START collects source sample UASO015 GPS coordinates.

Four samples of the mine waste pile at the Gold King 7 Level Mine were collected in accordance with the approved FSP. Sample UASO015 was collected from an area that was being actively eroded by the North Fork of Cement Creek, from material that appeared to be similar to the fine-grained limonite colored material (Appendix A, Photo 7). START personnel also collected source samples from each of the three types of mine waste material identified with the field XRF. One Matrix Spike/Matrix Spike Duplicate (MS/MSD) sample was collected with the sample from location UASO018.

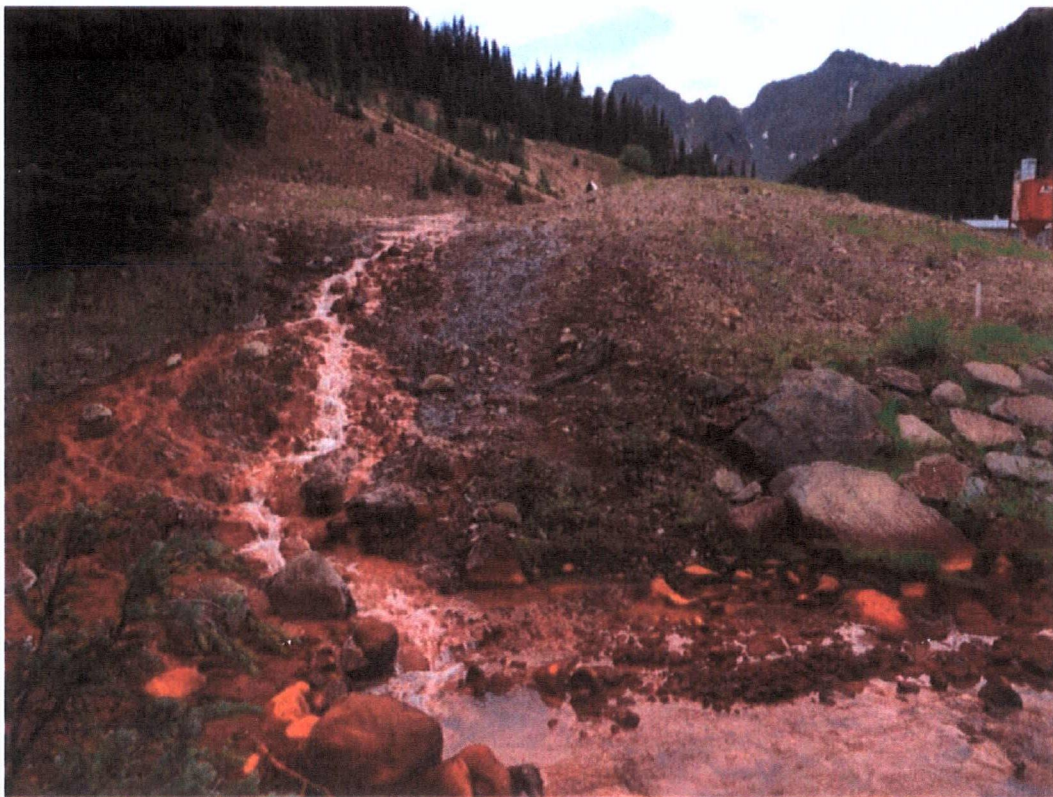
PHOTO 10

PPE from the American Tunnel outlet entering into Cement Creek. Note strong iron oxide staining downstream of PPE.

- **American Tunnel:** The discharge point for the American Tunnel is found just upstream of Gladstone where the discharge emerges from the diversion structure and flows approximately 200 feet westward to its PPE with Cement Creek. Strong iron oxide precipitate staining of the discharge and Cement Creek below the PPE was observed in August 2011 (Appendix A, Photo 10).

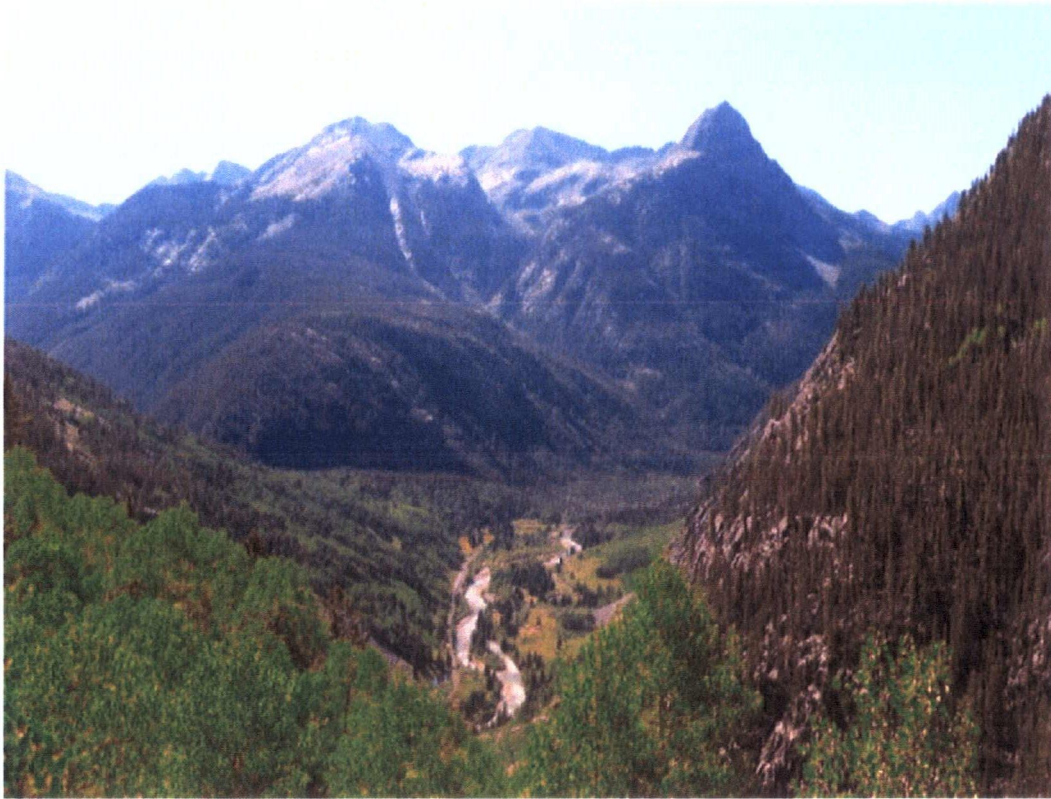
PHOTO 11

Elk Park is an open area in the Animas River Canyon below Silverton where the State of Colorado conducts electroshocking and passengers from the Durango & Silverton Narrow Gauge Railroad are dropped off to fish the Animas River. Access is also gained from Molas Lake via the Colorado Trail which crosses the Animas River in Elk Park.

START investigated the potential fishing activity along the Animas River downstream of the confluence of Cement Creek with the Animas River, south of Silverton, Colorado. Elk Park, an open area in the Animas River Canyon where the State of Colorado performs fish count studies every 5 years, was investigated. A fishing lure was found in a tree along the river bank, but no fishermen were observed during the investigation (Appendix A, Photos 11 and 12). The Colorado Trail passes through Elk Park and the area is also used for camping. No evidence of river rafting was observed during the site reconnaissance.

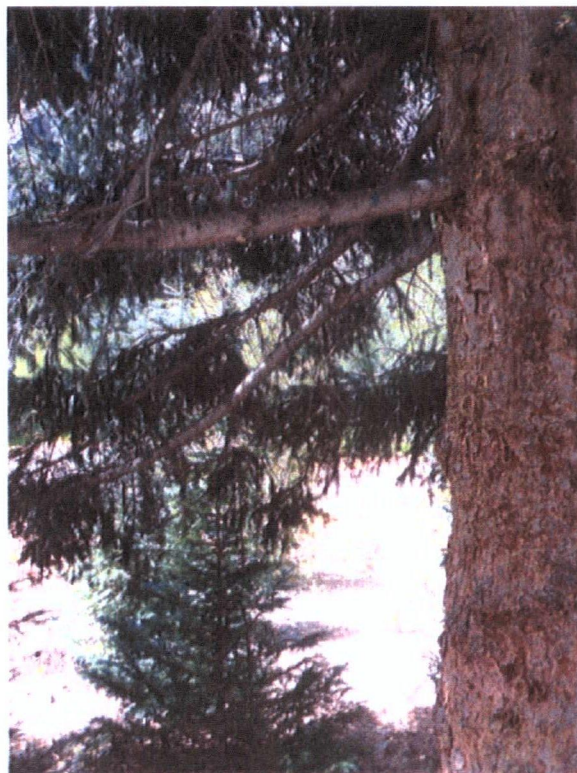
PHOTO 12

A fishing lure found imbedded on a tree limb along the banks of the Animas River in Elk Park. Lure is bright green on larger limb near the trunk.
